# Terragong Unlocking the Past

*By Simon Milner.*

*Five (of a total of six) internal doors off the central hallway at Terragong feature wonderful door furniture that was no longer in full working order. This is the story of the restoration.*

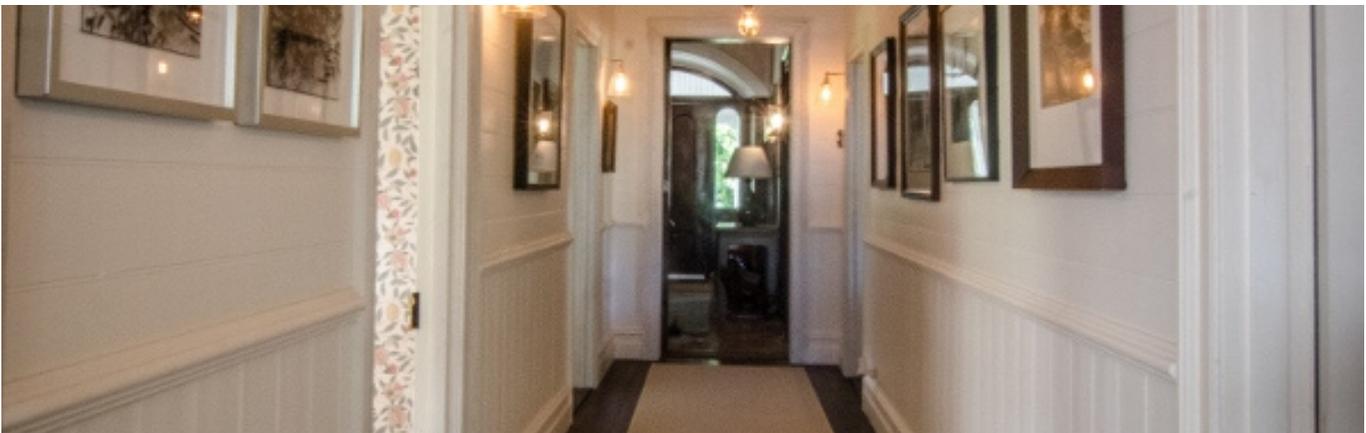
Our refurbishment of this part of the house included removing, repairing and rehangng all of the doors. Five (of a total of six) internal doors off the central hallway - three guest rooms, butlers' pantry and passage door from the entrance foyer - feature wonderful door furniture that was no longer in full working order.

The locks are made of cast iron and brass, the accompanying strike plates of cast iron with brass detailing. As the doors were taken down for repair, the hardware was tagged according to which doorway it had been removed. Following the advice of our restoration carpenter Red, liberal amounts of paint stripper were applied to remove the multiple layers of paint. Once stripped of the majority of paint, a buffing with extra-fine steel wool exposed the original surface of the cases, whilst preserving a rich patina.

Further online research (and quite a few phone calls later) led us to K9 Locksmiths in Sydney, who had previous experience working with locks from this period and were able to repair the lock mechanisms and create new keys. The locks and their strike plates were packed into individual boxes and delivered to K9's workshop. Key blanks were sourced from what we understand to be the sole remaining skeleton key blank manufacturer in Australia (in Tasmania) and each was hand-cut and filed, not an inexpensive exercise, with each key blank costing approximately \$100.

We ordered three keys per lock, as well as two master skeleton keys able to open all locks. A few weeks later the locks and strike plates were returned to us in working order, each with three keys.

We gave their exteriors a final clean and polish, a blacking and a protective wax coating and passed them to Red our carpenter, who reinstated them on their respective doors.

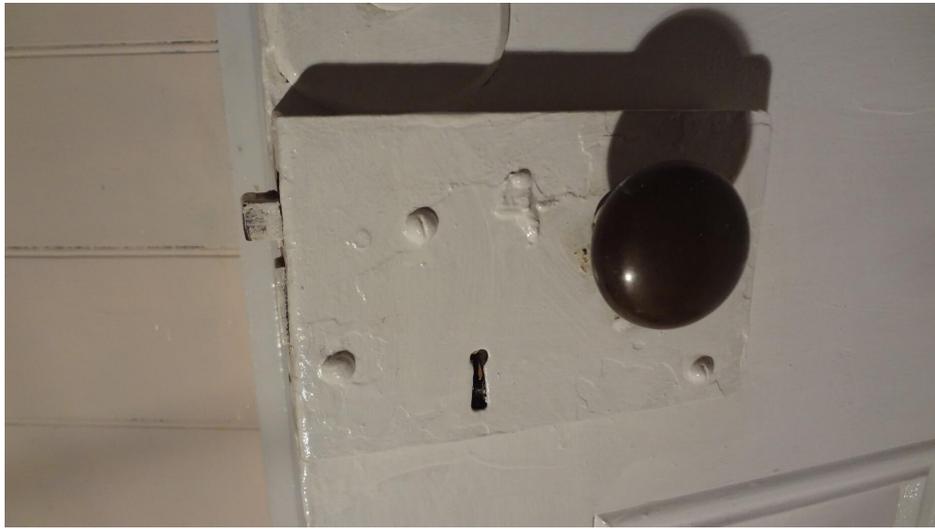
**Pre-refurbishment**

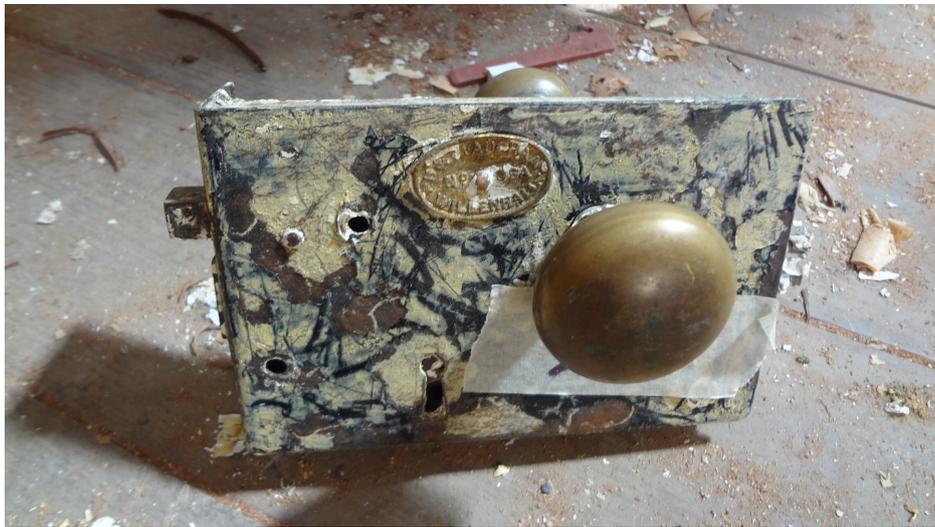
**After third application of paint stripper**

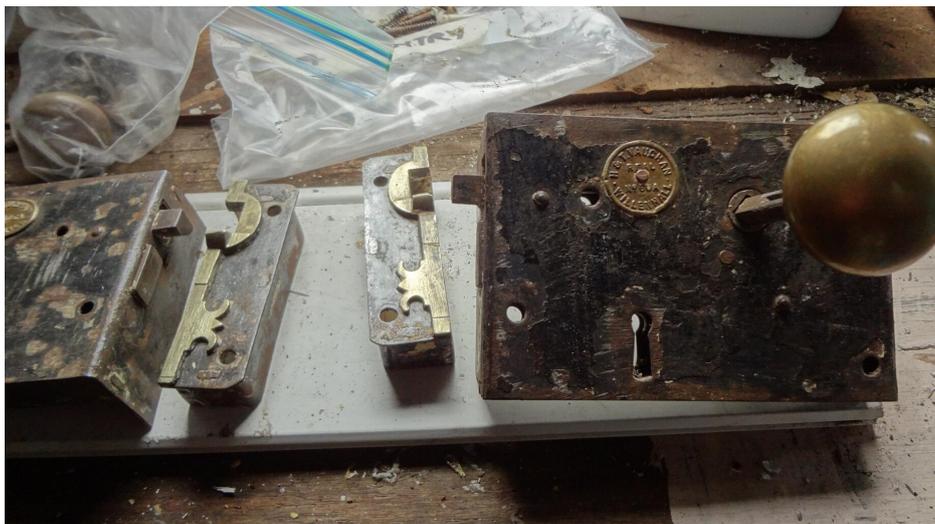
**All paint removed**

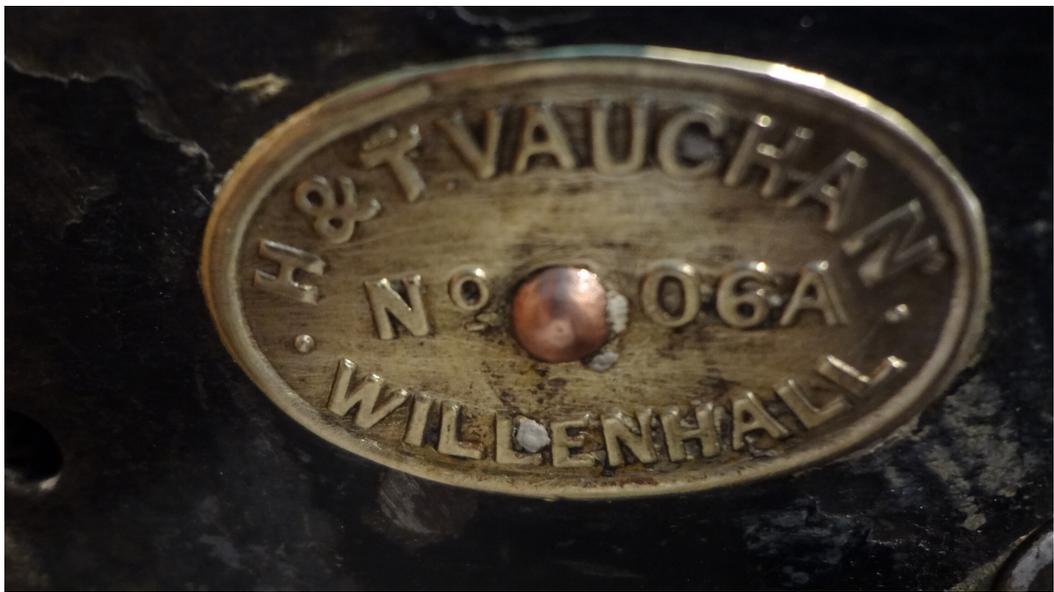
Manufacturer's lozenge detail

Removing the paint revealed brass medallions bearing the name of the manufacturer as well as a model number. Jumping online (thank you Google), we learned that they were manufactured by H&T Vaughan in Willenhall, England, circa 1875-1880. The company was established in 1856 and during the latter part of the century Australia and New Zealand were their primary export markets (more information can be found at <http://lockcollectors.eu>). Based on this information, a date of 1880 for the rebuild seemed likely.

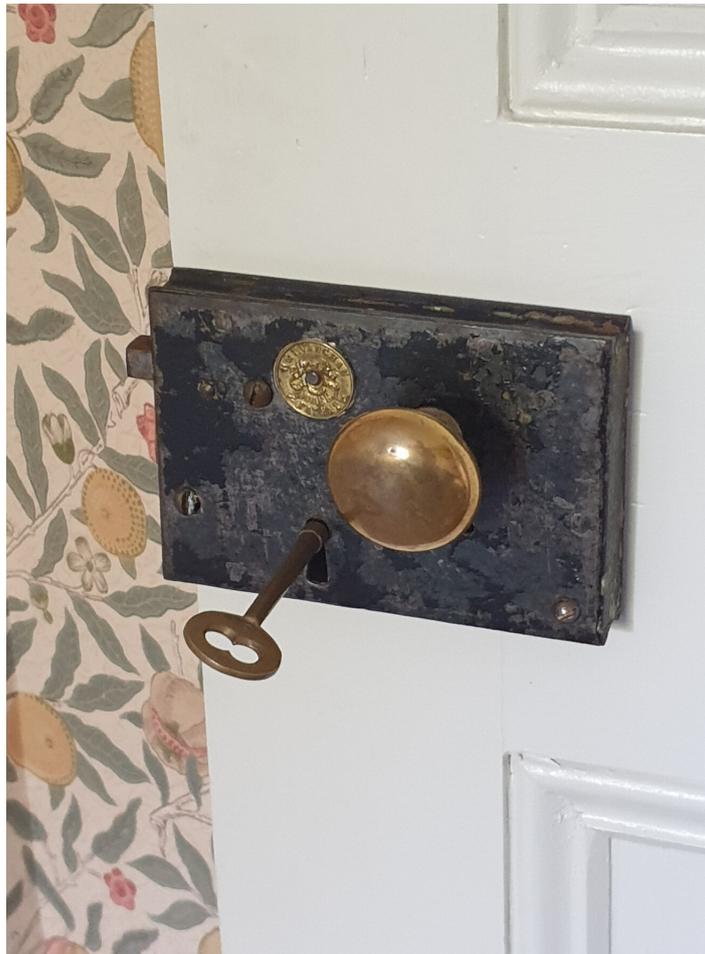
**Finished result**

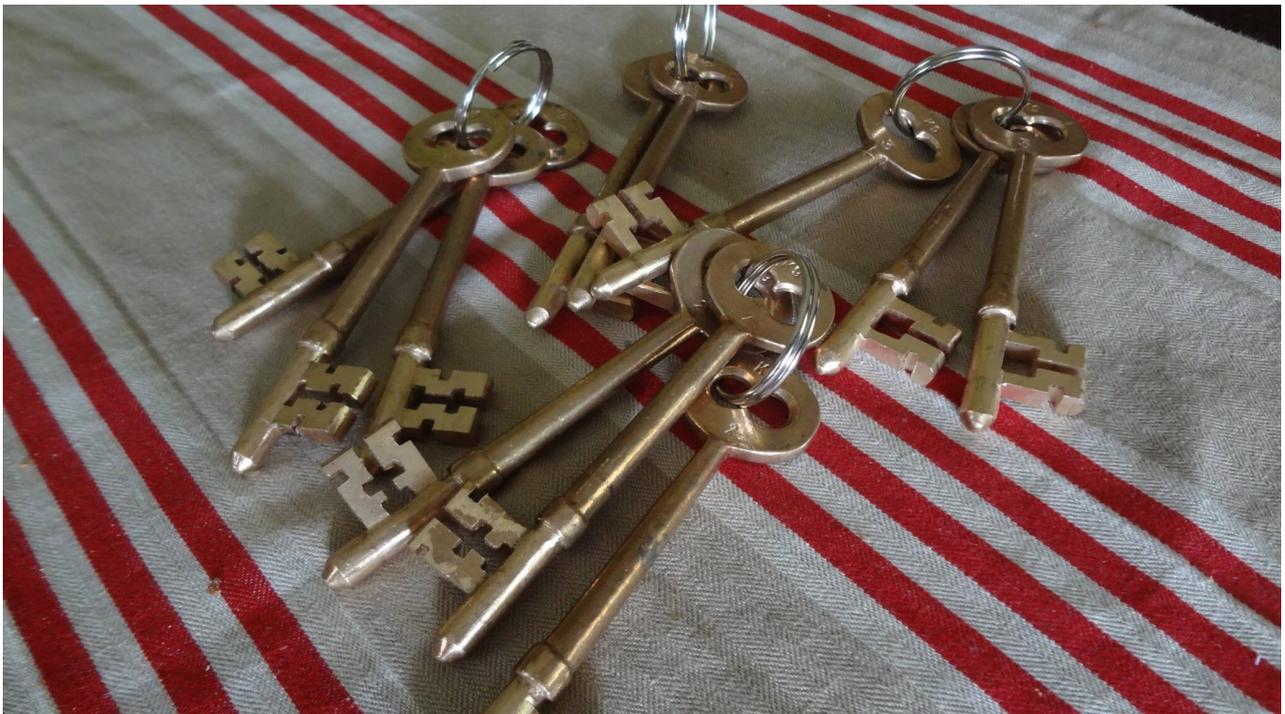
**New keys**
